Flood Hazard Assessment Report Buckhorn Creek, Larimer County, Colorado

June 5, 2013

Purpose: The purpose of this report is to summarize the findings of our (NRCS) site evaluation of the Buckhorn Creek Area in relation to potential flooding that could be expected from the Watershed after the High Park fire.

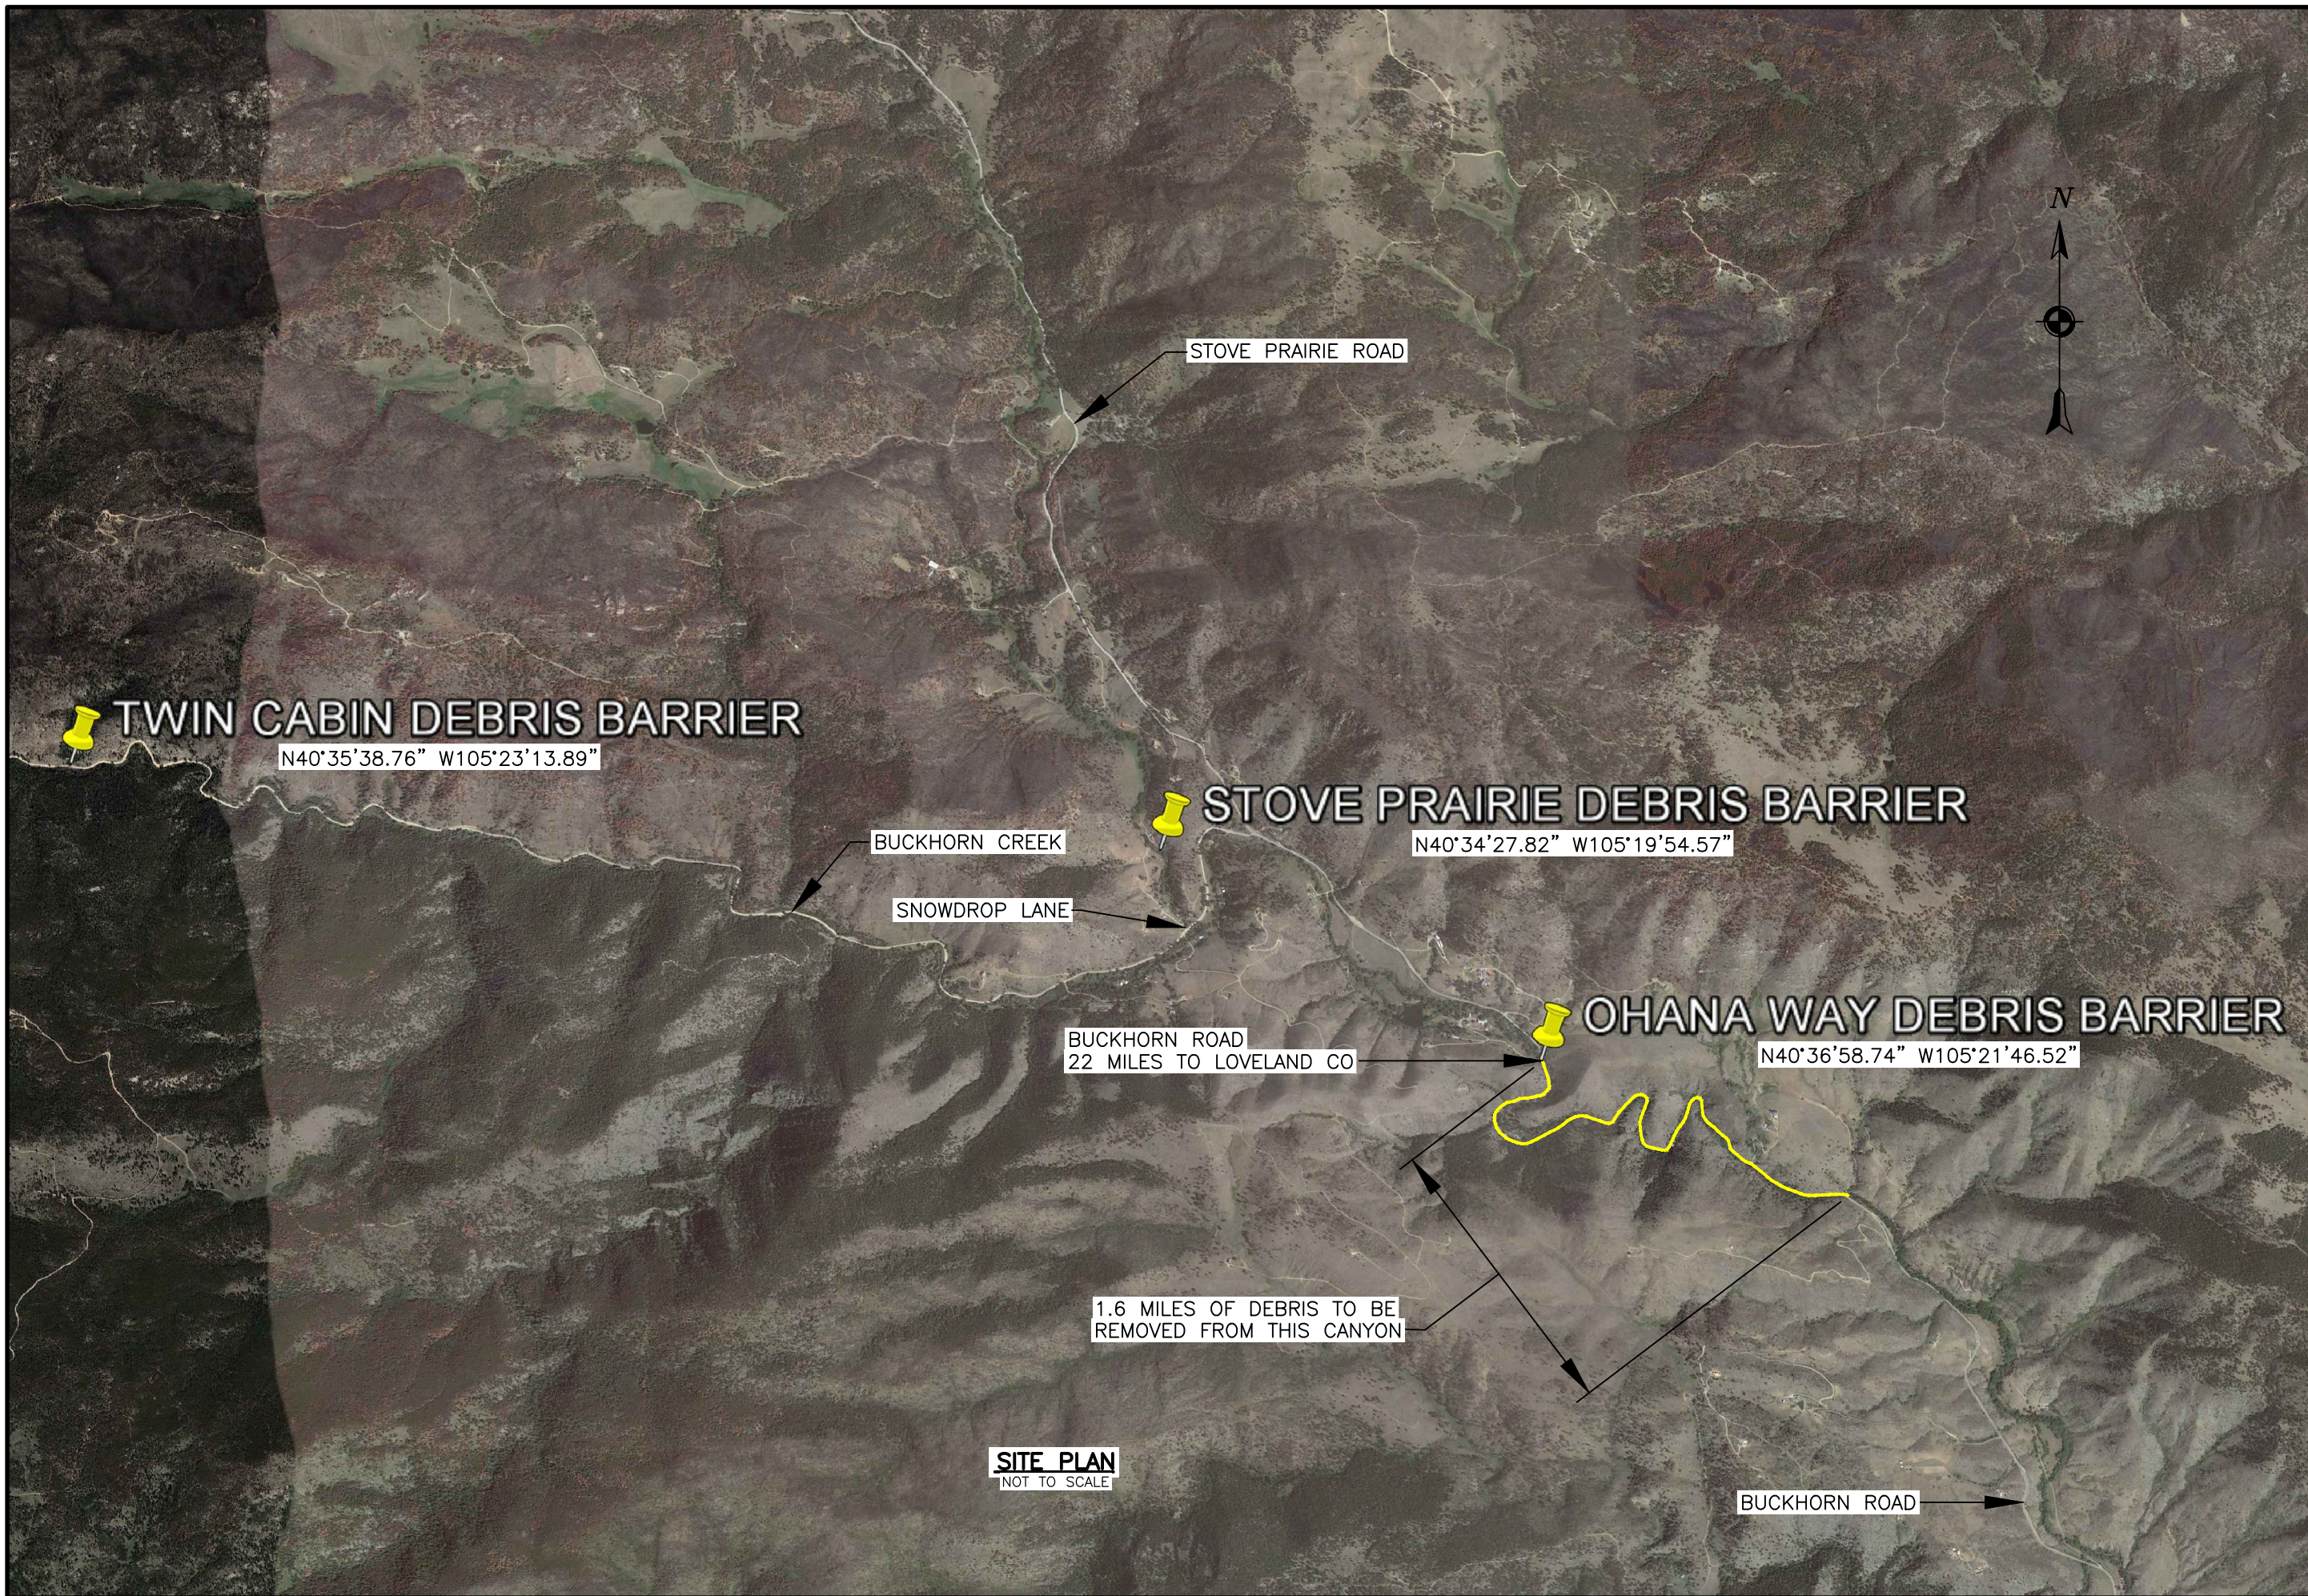
SITE PLAN
NOT TO SCALE

1.6 MILES OF DEBRIS TO BE
REMOVED FROM THIS CANYON

Debris Control: Flood flows in Buckhorn Creek are capable of transporting large rocky and woody debris. The construction of debris control structures should be considered to prevent large material from potentially blocking flows and washing out road culverts and bridges. The suggested location for the three (3) debris control structures was identified at (1) Twin Cabin Gulch and Buckhorn Road, (2) Stove Prairie Creek and 30 Snowdrop Lane, and (3) Buckhorn Creek and Ohana Way.

Debris Removal: Considerable debris exists in the Buckhorn Creek flow channel. The specific concern is transported debris will plug downstream culverts causing overtopping and blocking the stream channel resulting in erosion of roadway (CR 27). The proposal is to remove all dead and downed woody debris one inch (1") in diameter and larger from the Buckhorn Creek channel between Ohana Way and 1.6 miles downstream of Ohana Way.
