Flood Hazard Assessment Report Hill Gulch, Larimer County, Colorado

January 24, 2013

Purpose: The purpose of this report is to summarize the findings of our (NRCS) site evaluation of the Hill Gulch Area in relation to potential flooding that could be expected from the Hill Gulch and Watha Gulch Watershed after the High Park fire.

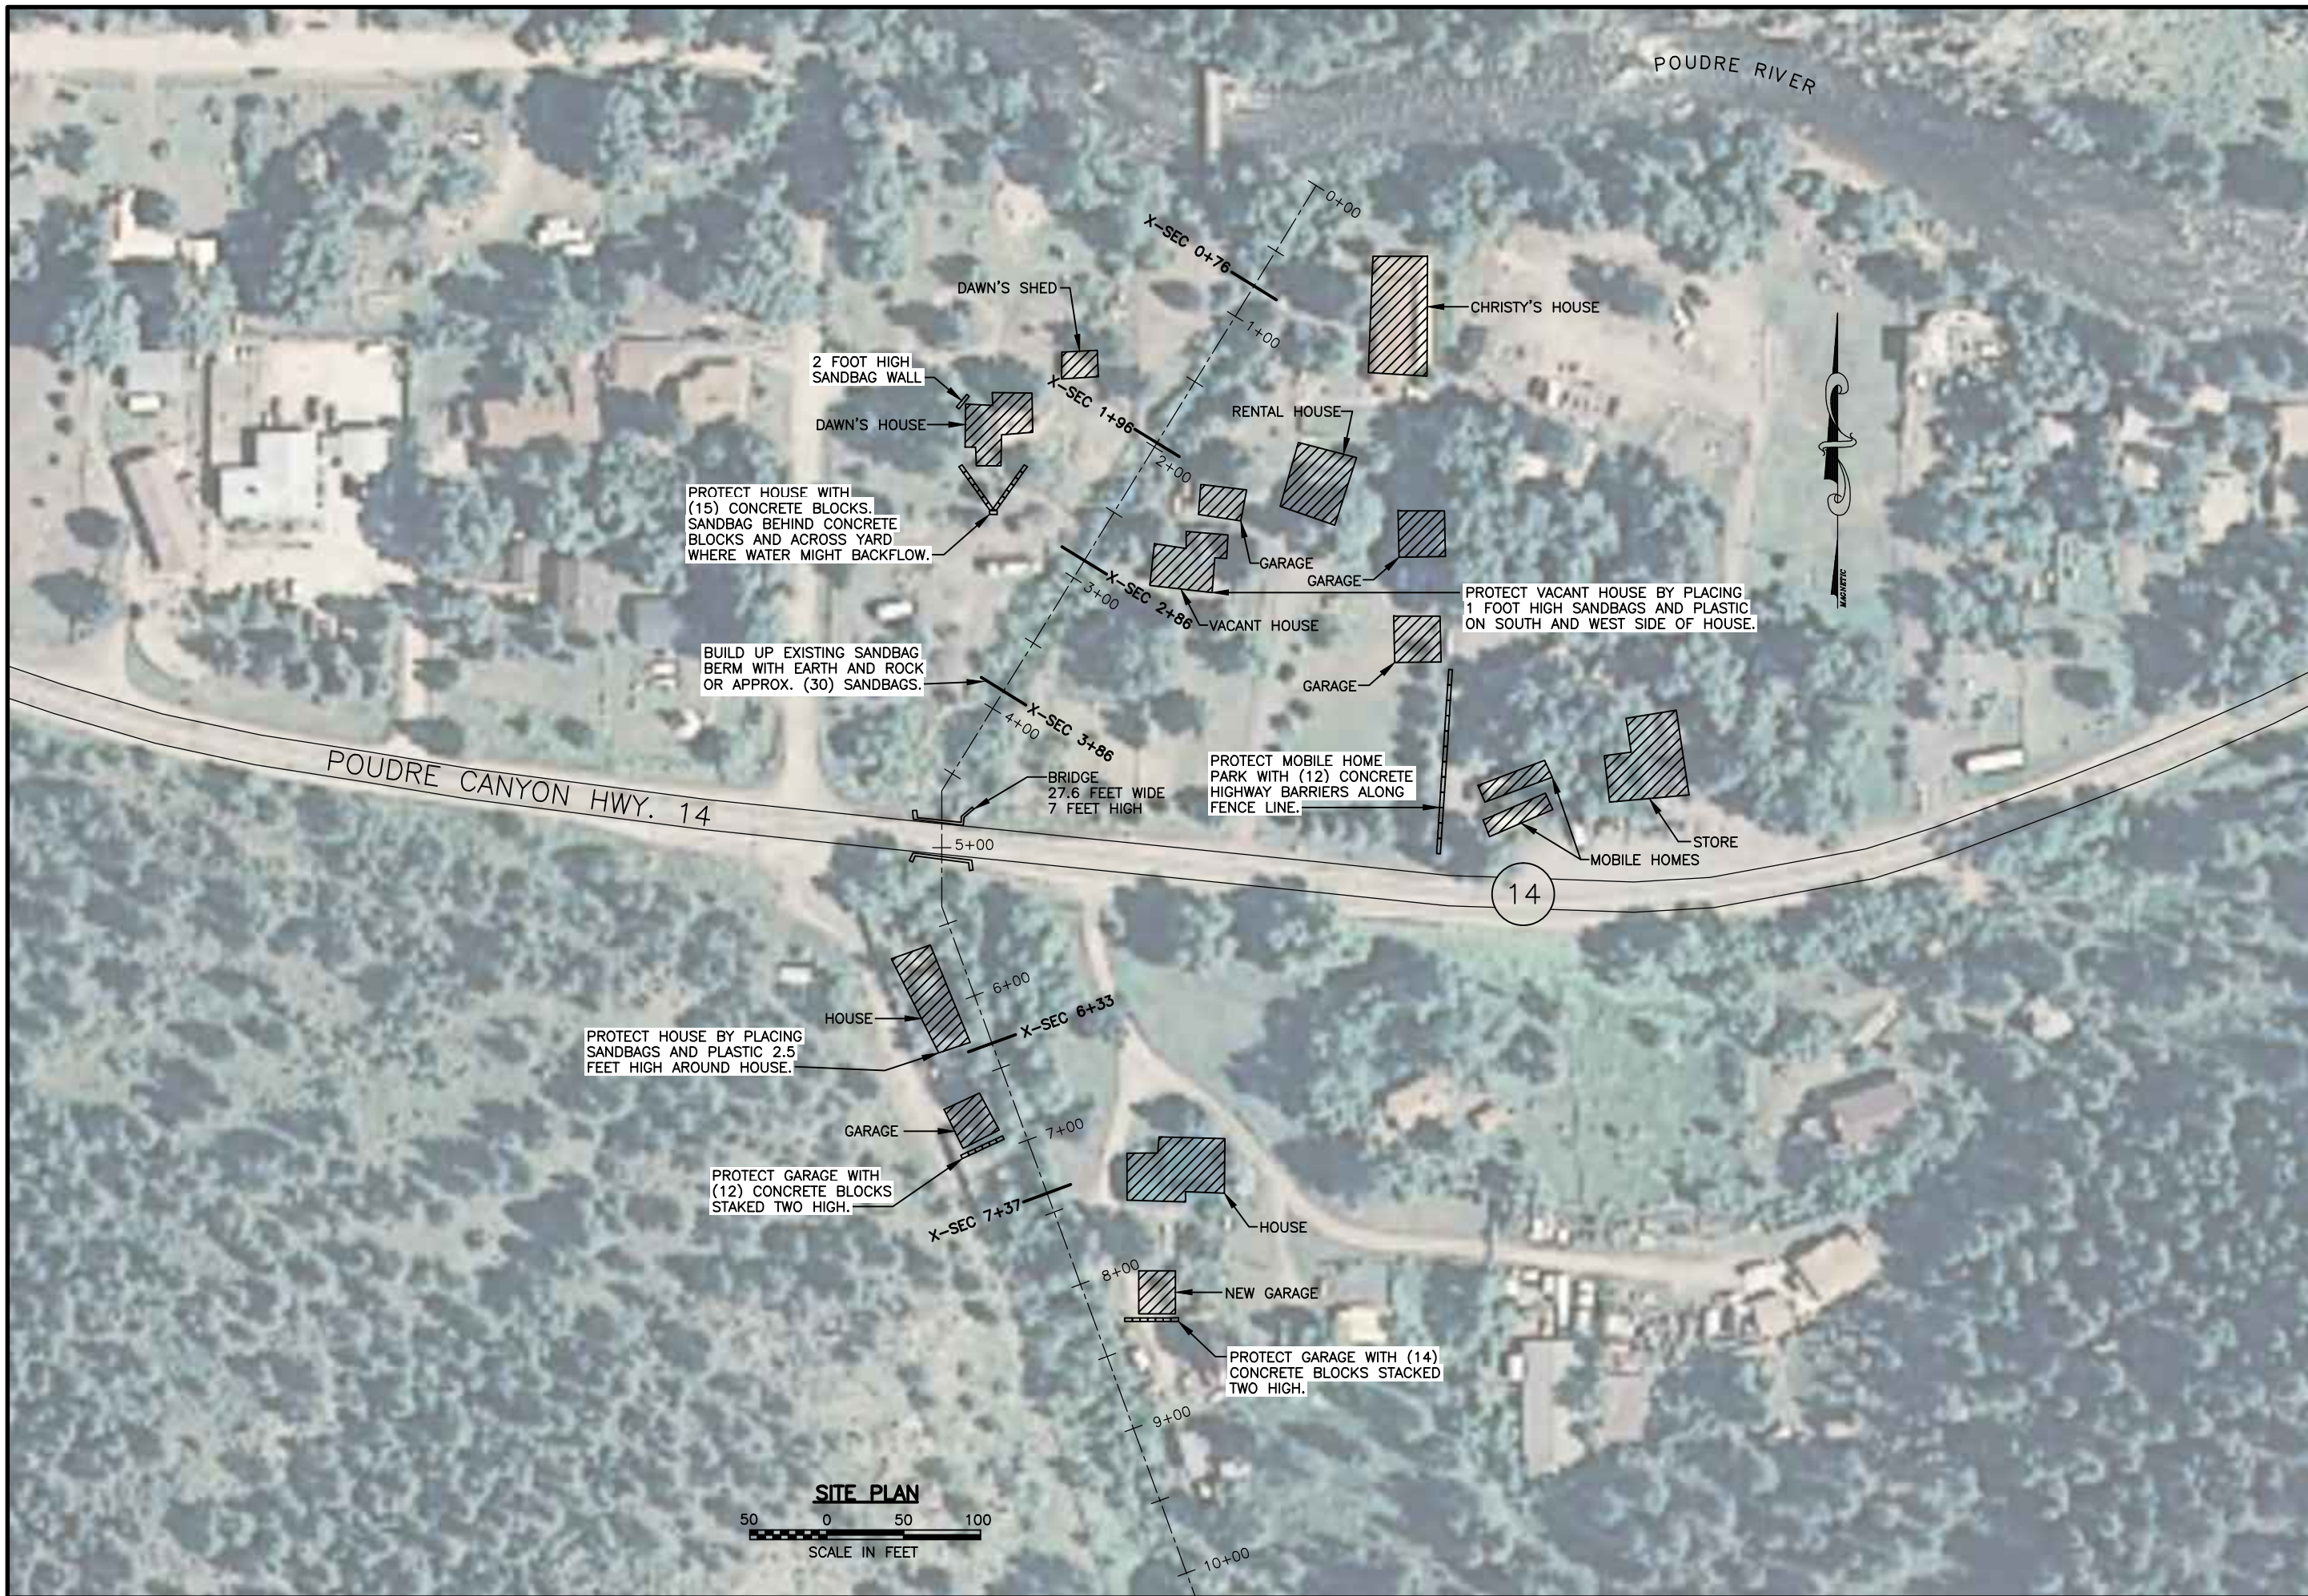
SITE PLAN
HILL GULCH FLOOD PROTECTION RECOMMENDATIONS
 HIGH PARK BURN AREA
 LARIMER COUNTY

Assets and Resources at Risk: There are two residences on the south side of Highway 14, upstream of the highway bridge, and four residences on the north side of the highway that are near the channel (see Site Plan). These residences are at risk, to differing degrees, of flooding and in at least one case, personal safety is a very serious concern. There are several mobile homes, cabins and a general store that may be at risk should flood water leave the channel in significant quantities and overtop the highway. Highway 14 would be impacted by flood water potentially causing damage to the highway along with the deposition of sediment and debris. This would pose a hazard to travelers and require cleanup and repair. Sediment, debris, and contaminants transported to the Poudre River by flood flows would negatively impact the resource which includes municipal and irrigation water supplies.

The house, at 17 Wonderful Pl. is not expected to be impacted by the 25 year if flow under the highway bridge is not seriously impeded by debris. The newly constructed garage in back of the house could be impacted by flood flows. A row of concrete blocks placed upstream of the garage from the hillside extending past the front wall of the garage would serve to protect the garage from direct impact of flood water and debris.

The house at 10049 Poudre Canyon Highway, on the south side of Highway 14, is at the greatest risk of flooding and damage from debris. Significant effort will be required to protect this home. A barrier constructed 2 ½ feet high on the upstream side of the garage and along the sides of the house will protect these structures from the direct force of the 25 year event. This calculation is based on the assumption that flood flows are able to pass through the gate next to the garage and continue down the driveway. Obstruction of flood flows at the gate either by a constructed barrier or the accumulation debris will result in raising the level of flooding elsewhere. Some effort has been made in the past to armor the stream bank at this location. Some of the rock-filled wire gabions constructed on the bank have been damaged. They should be reconstructed in order to provide protection for the stream bank. Given the unpredictability of the magnitude of precipitation events, it may not be practical to provide complete flood protection at this house. Regardless of the protection, this house should be evacuated if a flood event is likely. Due to the potential loss of the structure and loss of life from flood flows, consideration of moving the house or buying and demolishing the house is recommended.

The house at 48 Poudre River Road could be flooded if flows overtop the channel bank. A barrier at least 1 ½ feet high constructed across the south and east sides of the house would serve to protect the house from the direct impact of flood water and debris by diverting flows to either side of the house. The barrier could be constructed of sandbags or large concrete blocks. The owner may consider constructing a barrier to prevent water from flowing into the basement on the north side of the house. A sandbags barrier 1½ feet high could be constructed across the driveway at the top of the slope going down to the basement. This barrier could also be constructed using large concrete blocks with sandbags placed to fill gaps to prevent flood water from flowing between and around the blocks. A barrier could also be constructed against the basement wall but it would have to be nearly the full height of the wall to be effective. Flood flows can be expected to pass on both sides of this house during a large flood event. It would be best to evacuate this house if a flood event is likely.

The houses immediately east of the channel and north of the highway are less likely to be flooded during a 25 year event. House number 9998, the house closest to the highway, could be subject to water levels 0.4 feet above the floor level. A sandbag barrier at least 1 foot high placed along the south and west sides of the house is recommended.

The owner of these properties may wish to consider placing a barrier along the driveway on the west side of the property to direct the flow away from residences and other buildings. Concrete highway barriers would work nicely. The barrier could also be constructed of sandbags. The owner should consider having some sandbags near the front of the general store to place across the doorway if flooding should occur.

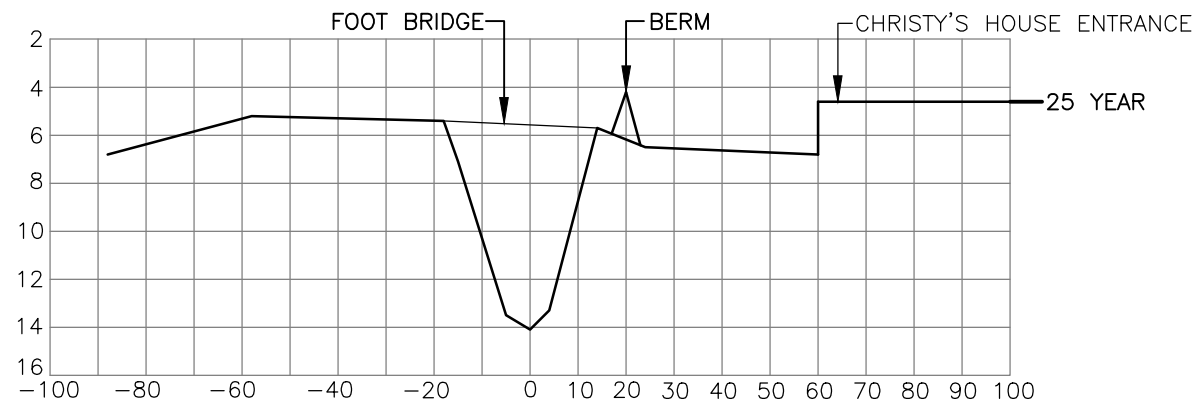
X-SEC 0+76
(158.23 S.F.)

Investigative activities: A reconnaissance of Hill Gulch was conducted from the Poudre River to about ½ mile to the south, upstream. Four cross sections were measured in the channel between the highway and the Poudre River. Two cross sections were measured south of the highway near the residences. Another cross section was measured at a potential site for a debris control structure. Members of the investigative team met with several of the potentially affected residents. The extent of previous flooding observed and reported by residents was documented. Hydrologic data developed using post fire conditions were used to estimate flooding potential along Hill Gulch at the cross section locations. The potential extent of flooding was estimated along the gulch and adjacent properties for the 25 year-1 hour flood event, 1.8 inches of rain in 1 hour, estimated to produce a flow of 1700 cubic feet per second (cfs).

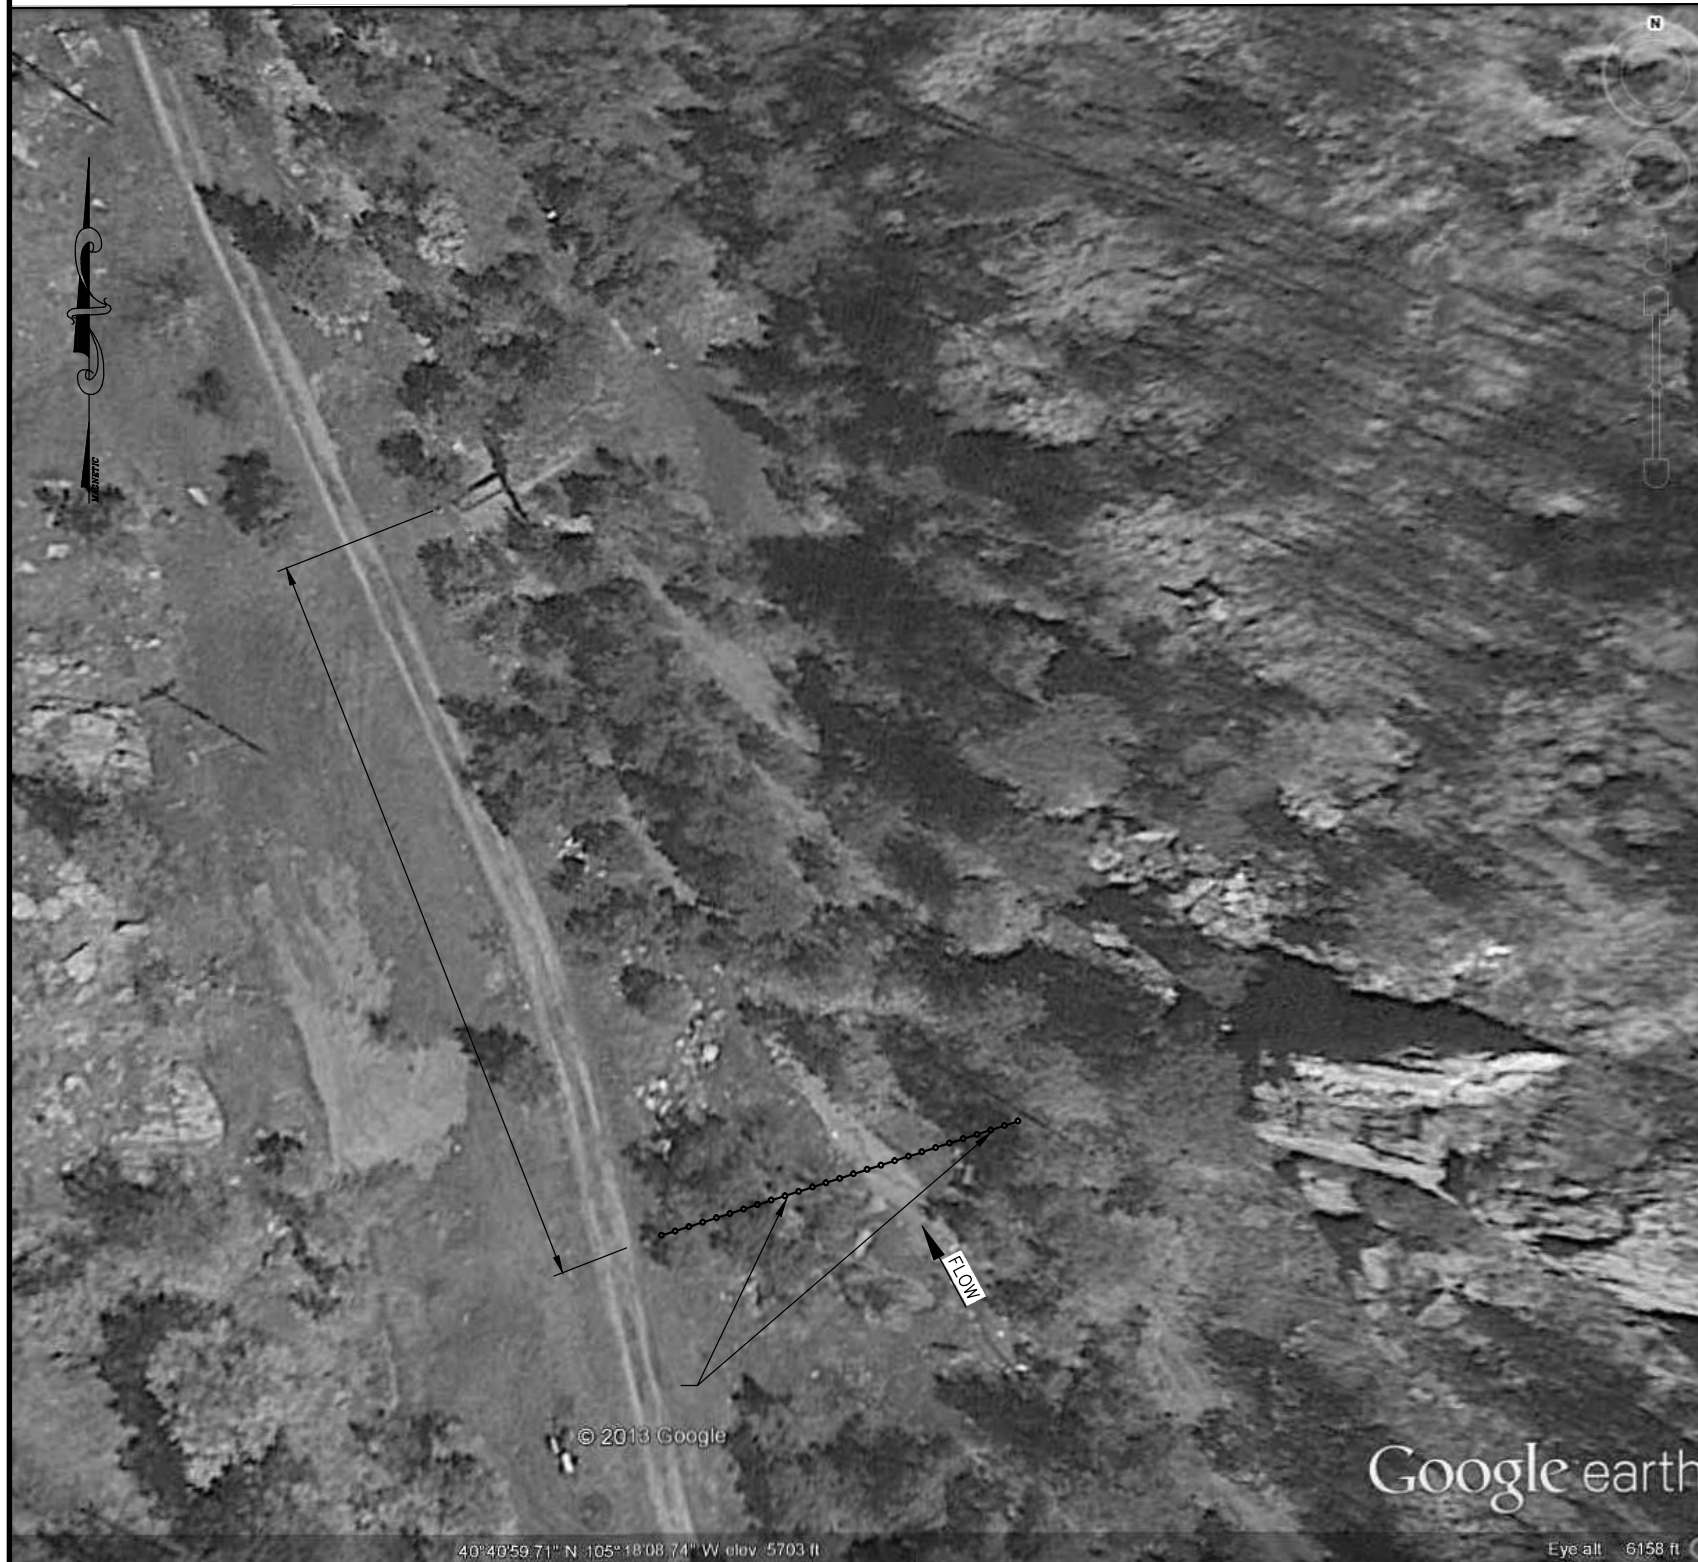
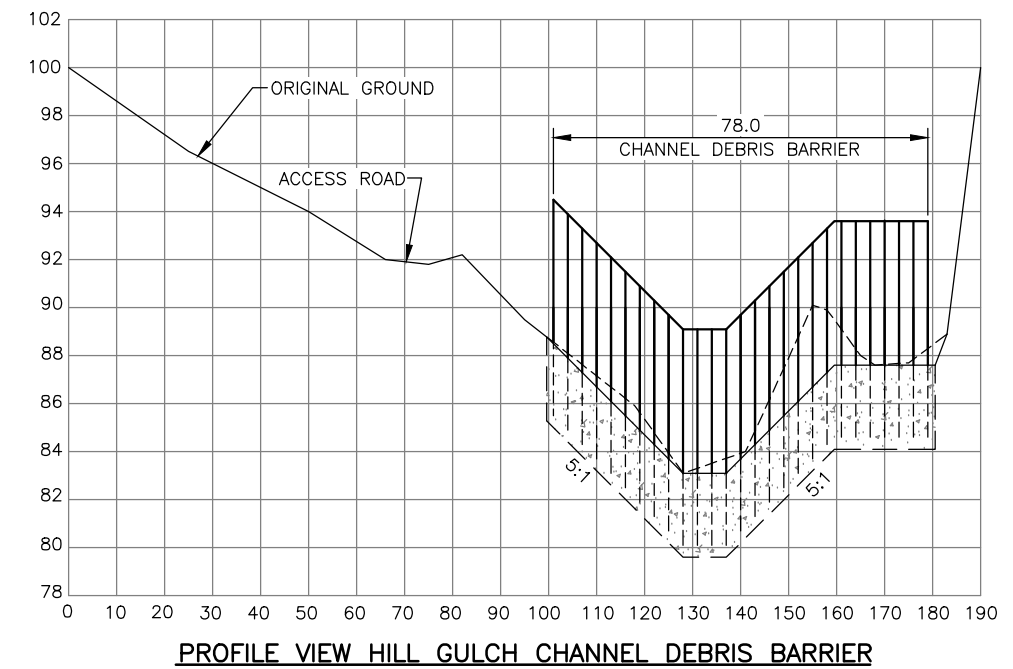
PLAN AND PROFILE VIEW CHANNEL DEBRIS BARRIER
 HILL GULCH FLOOD PROTECTION RECOMMENDATIONS
 HIGH PARK BURN AREA
 LARIMER COUNTY COLORADO

Debris Control: Flood Flows in Hill Gulch are capable of transporting large rocky and woody debris. The construction of a debris control structure should be considered to prevent large material from being transported onto people's property and/or potentially blocking flow under the highway bridge. The suggested location for the debris control structure is approximately 1100 feet upstream of the Highway 14 bridge. This location is about 150 feet upstream of the burned bridge.

A design for a debris control structure approved by NRCS is included with this report. There are other design approaches that could be utilized depending on the needs and resources of the community. A debris control structure could be constructed of logs or structural steel members embedded in concrete. The advantage of a log structure is the abundance of available material nearby. Also these log structures will gradually decay as the years pass and the forest recovers lessening the need for such structures. The advantage of the structural steel trash rack is that they are relatively quick and easy to construct. They are very durable and effective but may have to be physically removed after the threat of debris flows has past. A design other than that presented here should be approved by a qualified engineer.

A debris control structure would have to be cleared of debris following a flood event in order to remain effective. Someone would have to accept the responsibility of clearing the trash racks.

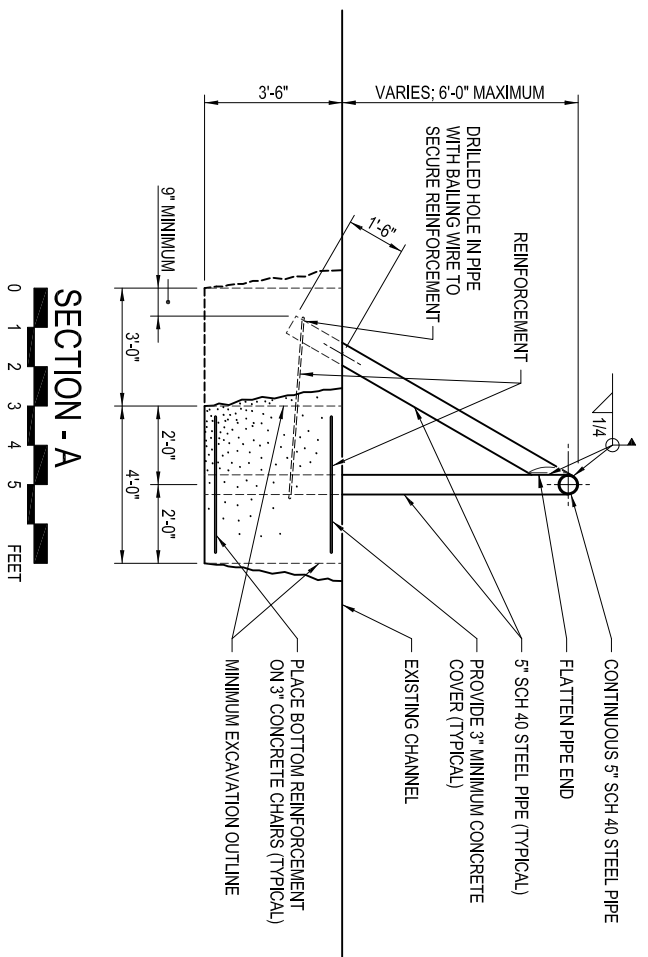
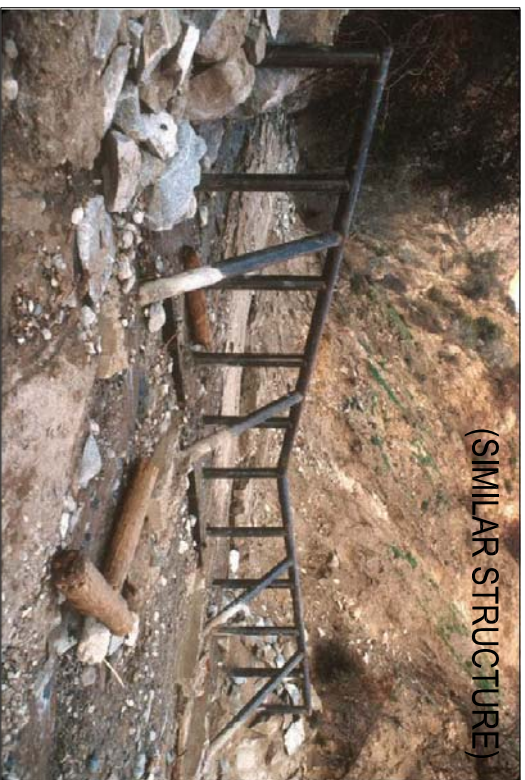
CHANNEL DEBRIS BARRIER

DETAILS, REINFORCEMENT, AND SECTION
6-FOOT MAXIMUM HEIGHT
